ACOUSTIC EMISSION MONITORING OF CRACK PROPAGATION ON THE EXPEDITED WING FATIGUE TEST ARTICLE (X993)

LOCKHEED-GEORGIA COMPANY
DIVISION OF LOCKHEED AIRCRAFT CORPORATION
MARIETTA, GEORGIA 30063

DECEMBER 1976

FINAL REPORT JUNE 1975 - OCTOBER 1976

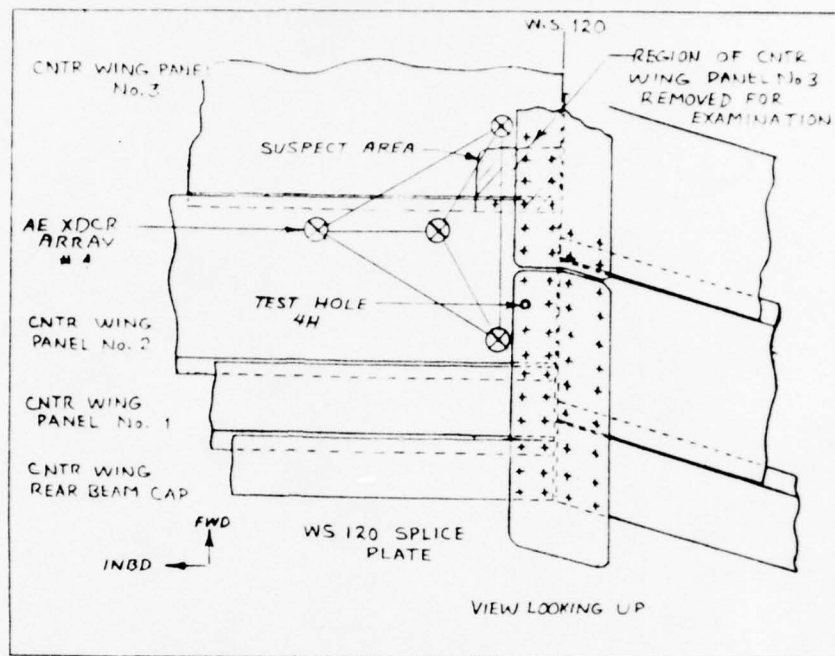
FIGURE 12. SECTION OF A CENTER WING (TEST AREA 4) REMOVED TO

INVESTIGATE PRESENCE OF SUSPECTED CRACKS

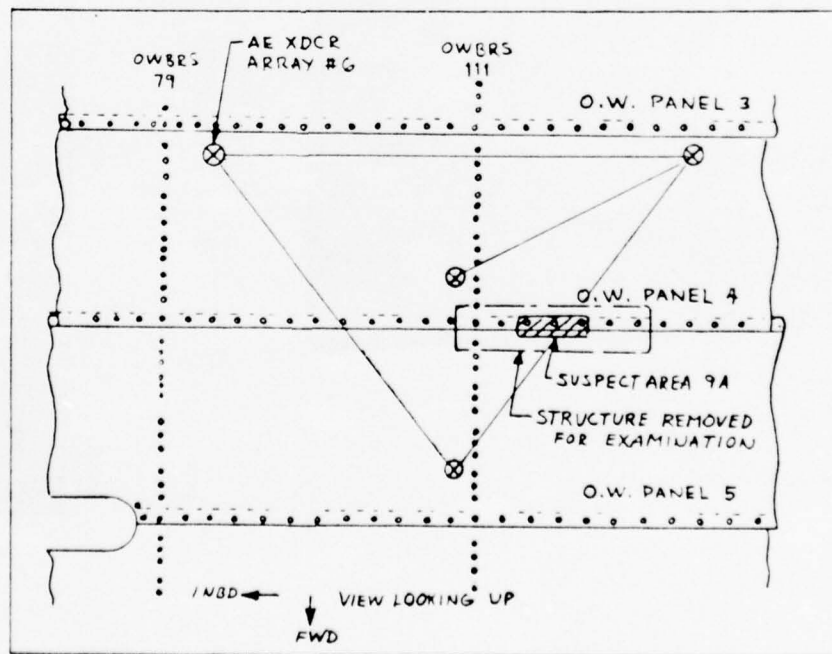
FIGURE 13. SECTION OF OUTER WING (AE TEST AREA 9) REMOVED TO

INVESTIGATE PRESENCE OF SUSPECTED CRACK

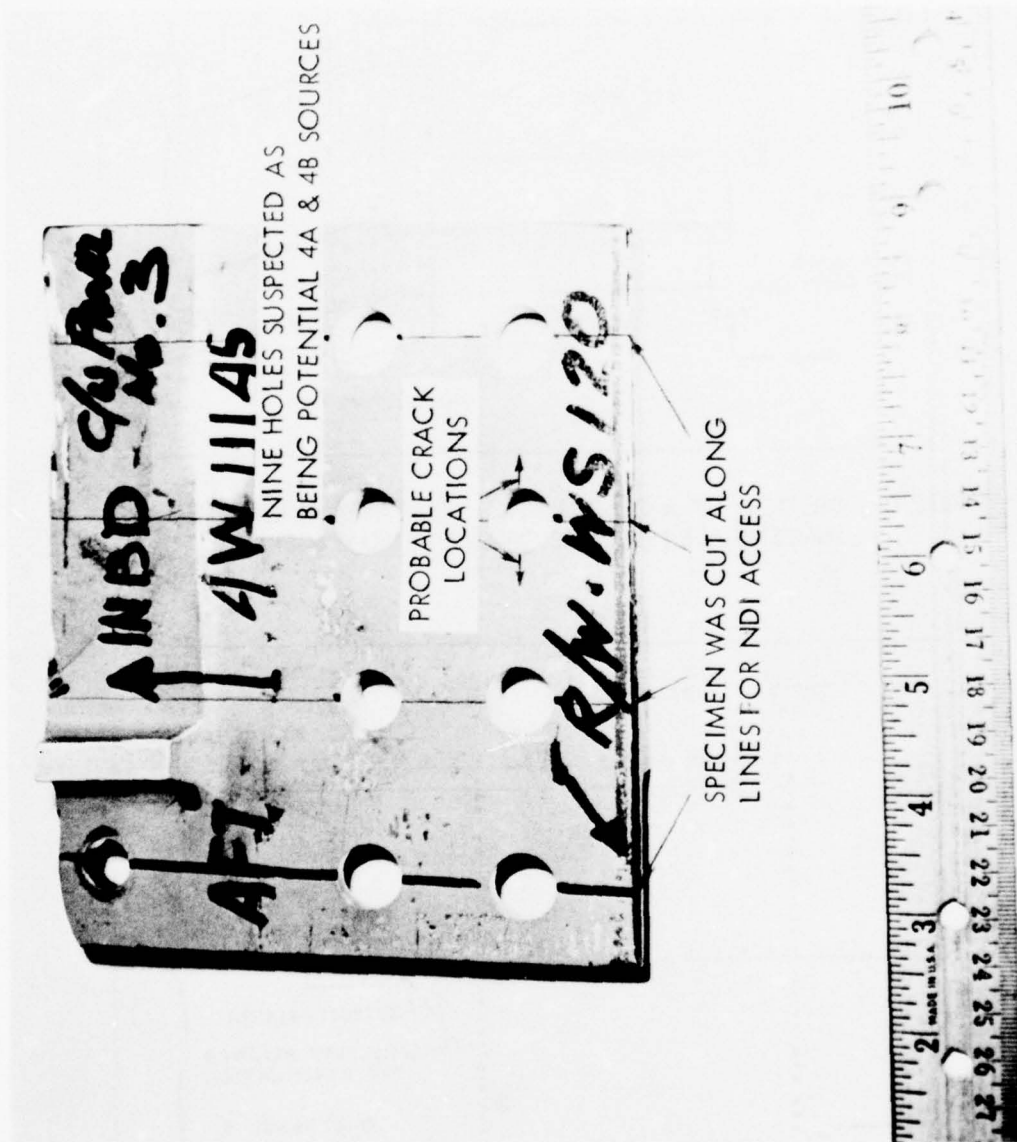
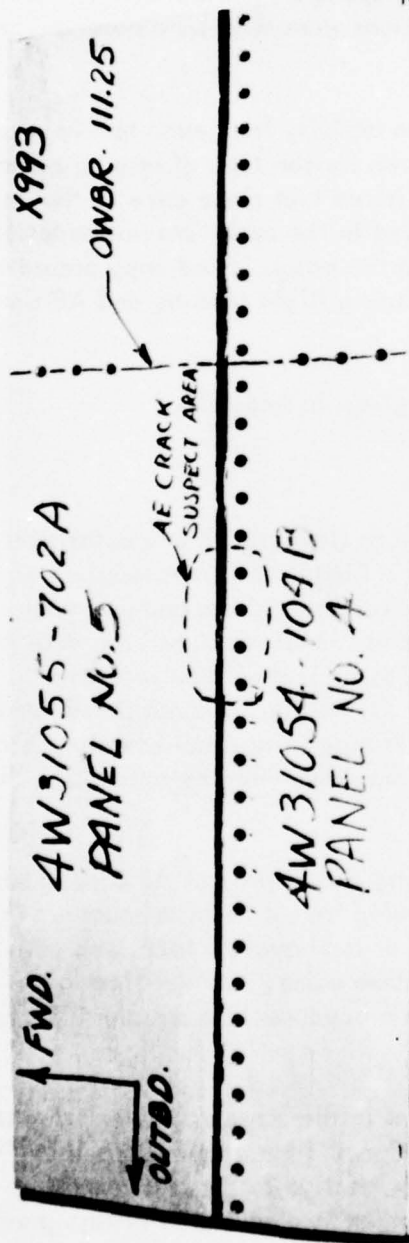
FIGURE 14. PORTION OF STRUCTURE FROM TEST AREA 4 CONTAINING CRACK SUSPECT AREAS 4A AND 4B

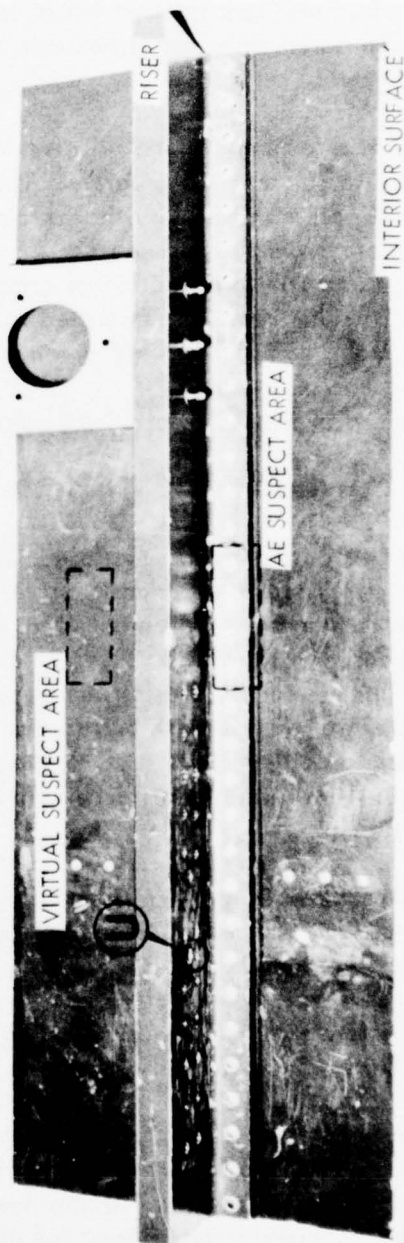
FIGURE 15. PORTION OF STRUCTURE FROM AE TEST AREA 9 CONTAINING CRACK SUSPECT AREA 9A .

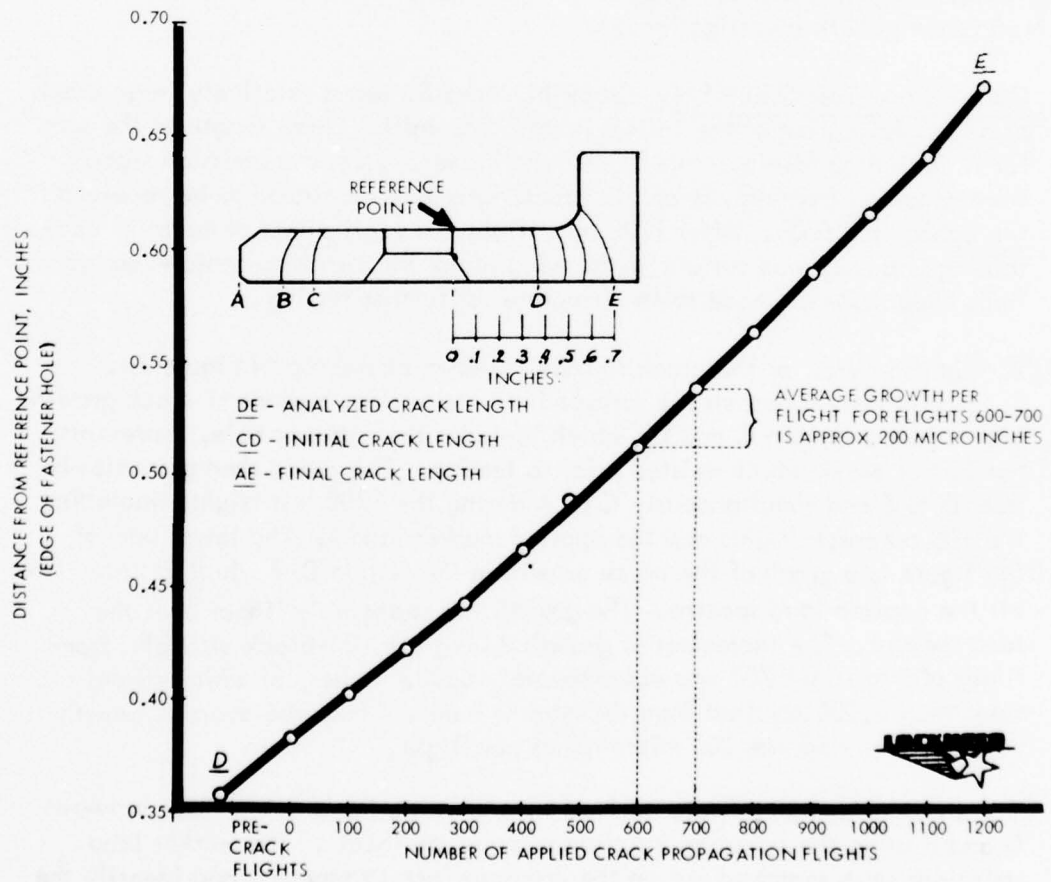
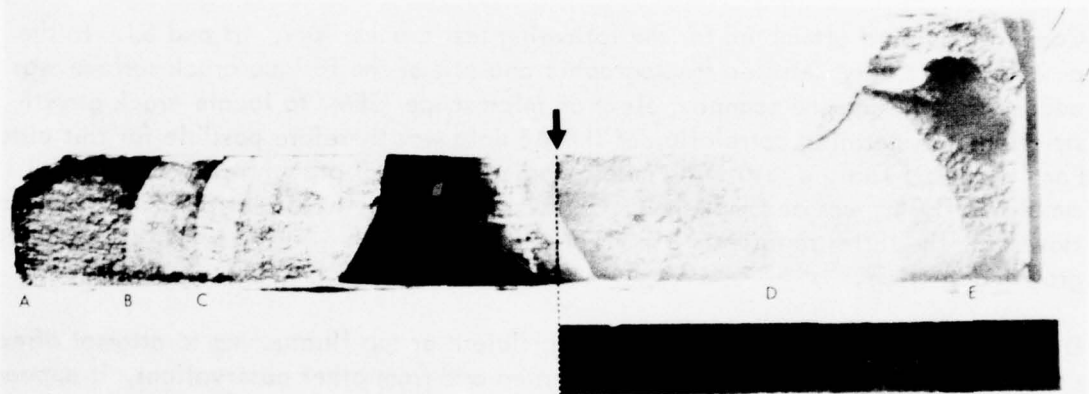
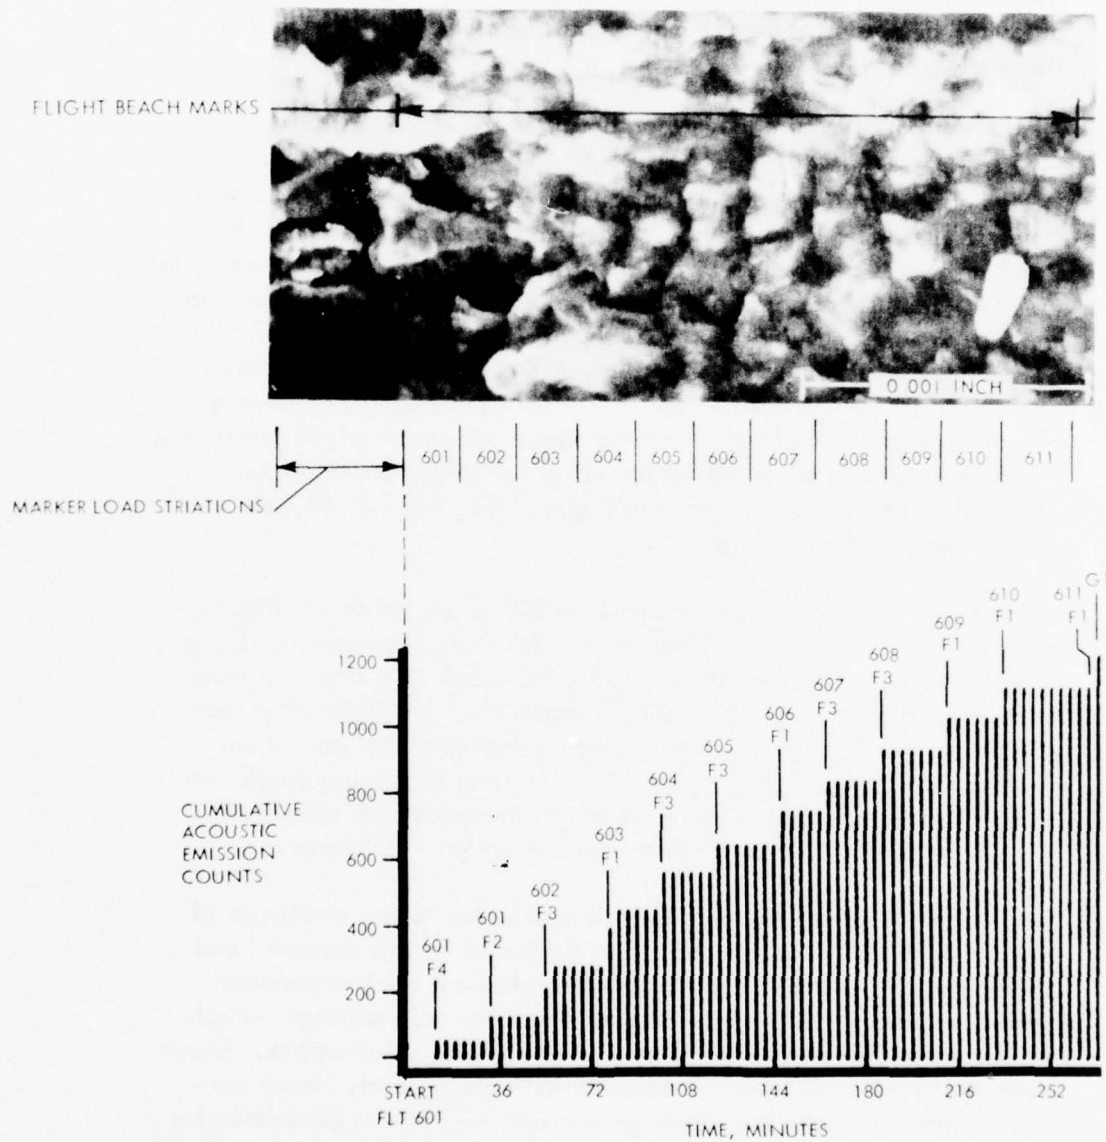
A magnified view of the crack surface is shown at the top of Figure 16. Bands of different hue on the surface indicate various regions of crack growth. The surface between C and D, which includes the fastener hole, represents the initial crack which existed prior to testing. The crack then grew slowly from D to E and simultaneously C to A during the 1200 test flights (including the 100 precrack flights and the applied marker loads). The lower part of the figure is a graph of the crack growth in the region D-E which resulted from all the applied load spectra. The growth was reasonably linear over the load spectra. The increment of growth during the 100-block of flights from flight 600 to flight 700 was approximately 0.026 inches, of which slightly more than 0.005 resulted from the marker loads. Thus, the average growth during this period was 200 microinches per flight.

The crack growth data were derived by analyzing the crack surface between D and E using the scanning electron microscope (SEM). The marker load striations were searched out on the crack surface to separate and identify the growth produced during each block of 100 unit test flights. A photograph showing a SEM view of a portion of the crack surface produced during test flights 601 through 611 is presented in Figure 17.

FIGURE 16. CRACK GROWTH HISTORY OF CRACK 'N'

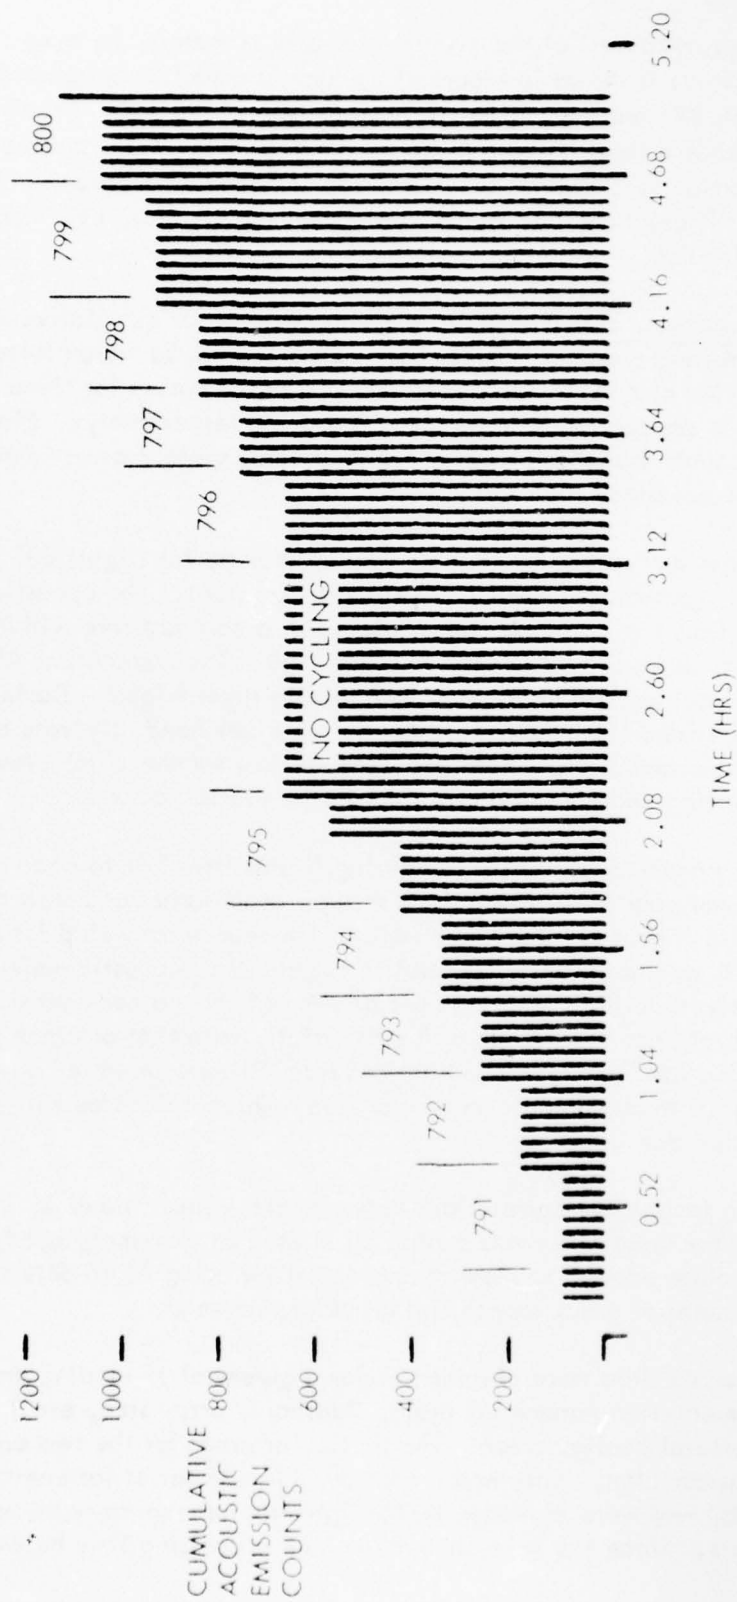
AE data from Crack N were analyzed at other flights. Figure 18 is a bargraph showing cumulative AE versus time for test flights 791 through 800. Most of the step increases, caused by single AE events occurred at the flight transitions. At these points, the amplitudes (number of

FIGURE 18. AE VERSUS TIME FOR CRACK 'N' AT FLIGHTS 791-800

ringdown counts) of the events were approximately the same. The amplitude is shown in Figure 19, which is a similar bargraph for flights 791 and 792. The flight transition at T-Flt 792 condition F1 shows a step increase of 88 counts over T-Flt 791, and the transition to T-Flt 793 showed a step increase of 82 counts. The other flight transition step increases were of similar, near constant, amplitudes.

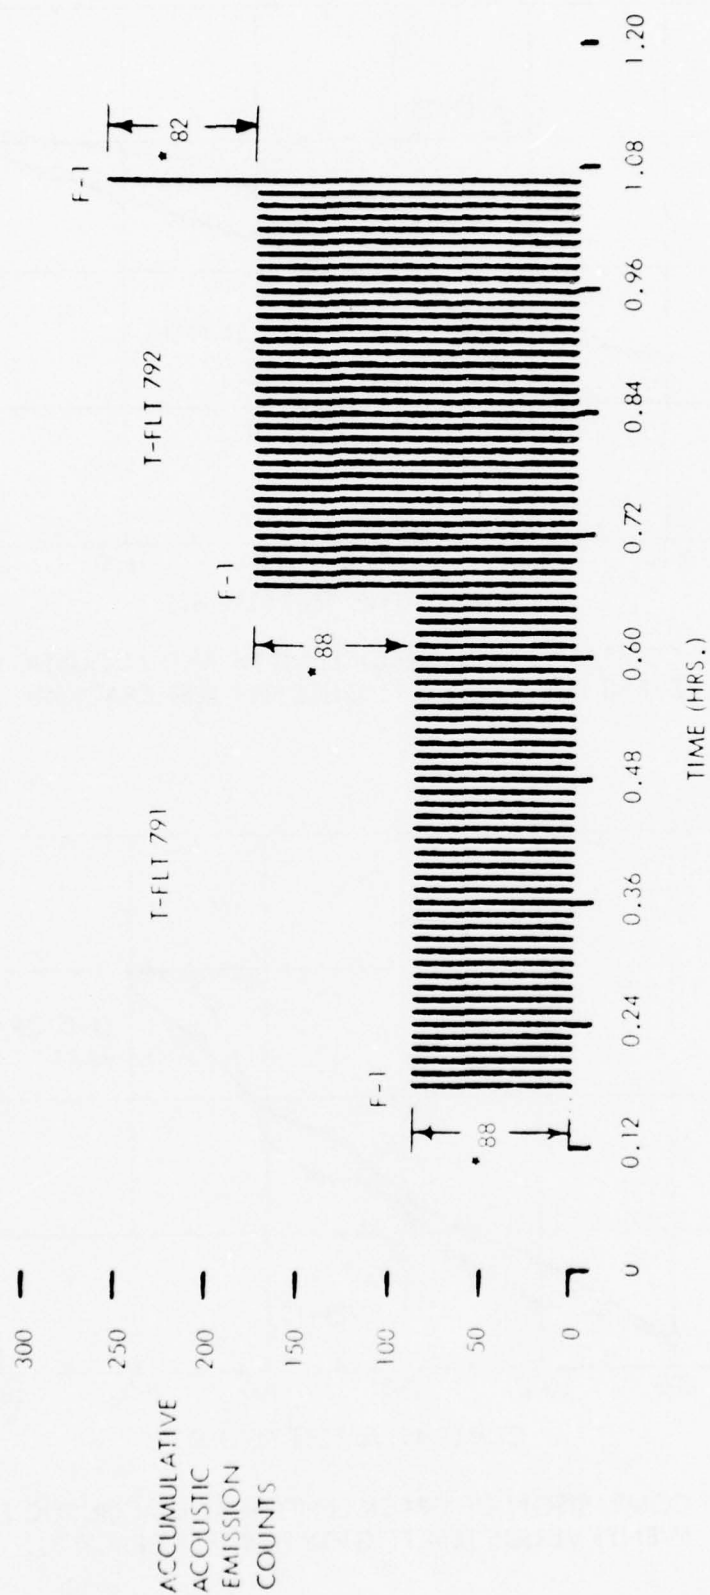
FIGURE 19. AMPLITUDE OF AE SIGNALS DURING FLIGHTS 791 AND 792

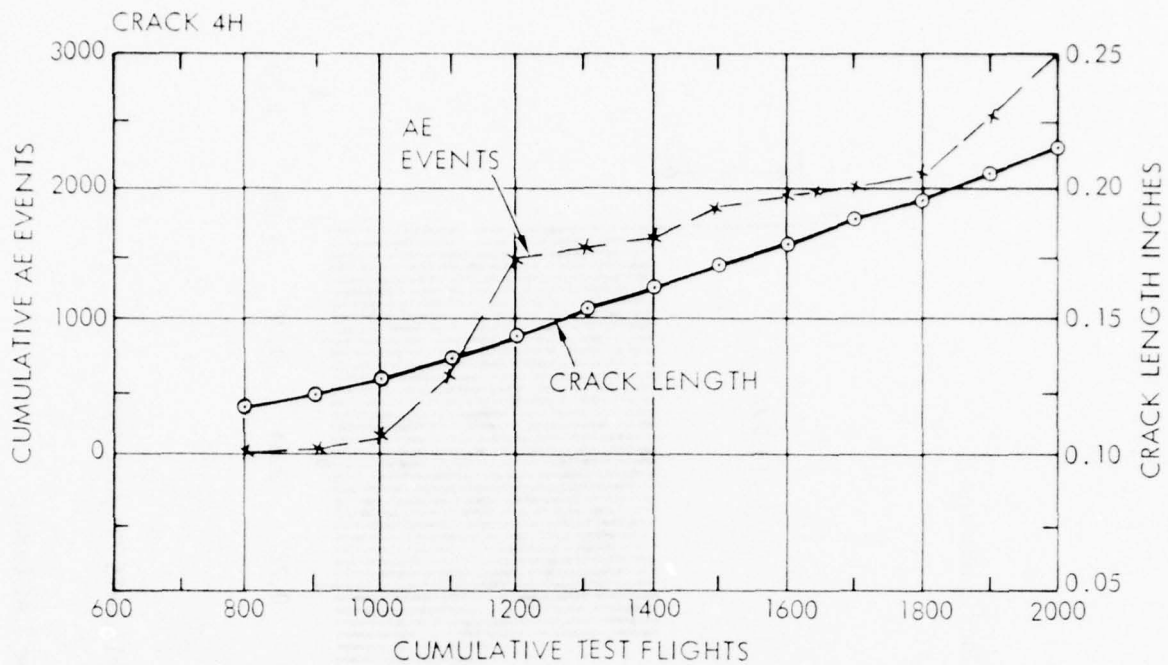
Correlation, Test Cracks 4H and 5J. Curves for cumulative AE events and crack growth for test cracks 4H and 5J were plotted as a function of cumulative test flights. A set of curves for these test cracks are presented in Figures 20 and 21, respectively. Plots of AE counts (not shown) instead of AE events present a very similar correspondence.

FIGURE 20. COMPARISON OF CRACK LENGTH AND ACOUSTIC EMISSION

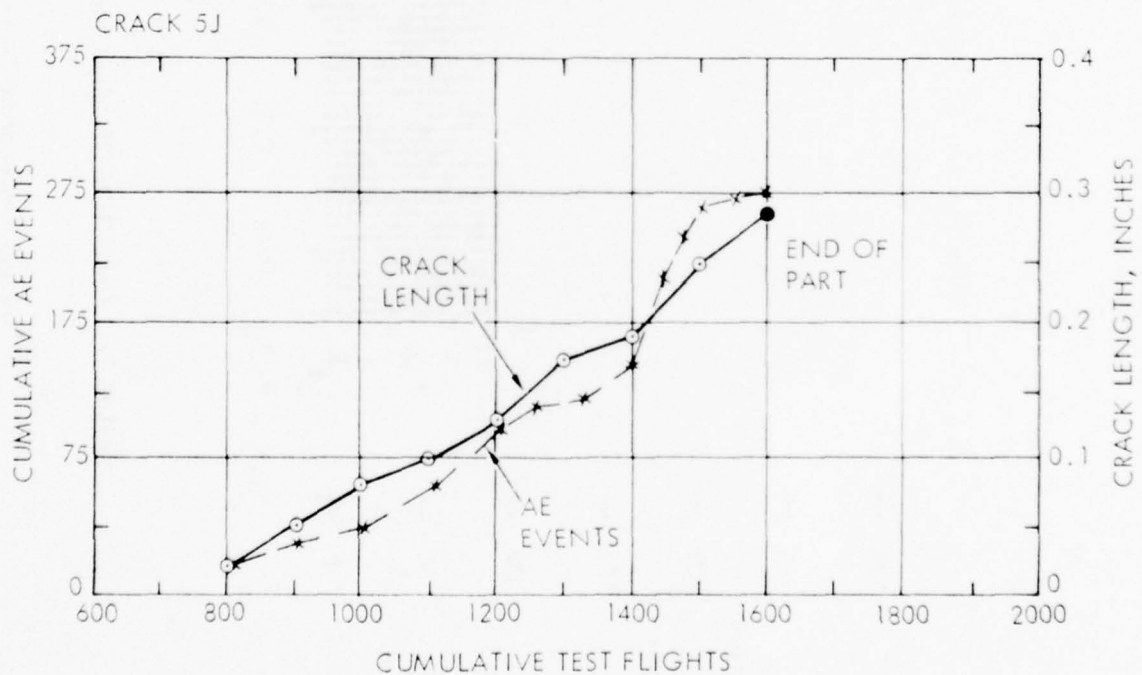
The growth for test crack 5J during flights from 801 to nearly 1600 was not constant. The growth showed small surges and slow downs before it reached the lower edge of the rear beam web prior to flight 1600, as indicated on the plot in Figure 21. Acoustic emissions received during the growth period did not show a constant accumulation rate nor did its rate coincide strictly with that of crack growth. During the flights, AE indications from 5J were observed on the AE monitor to be sporadic in arrival rate, which coincides with the plotted data.

FIGURE 21. COMPARISON OF CRACK LENGTH AND ACOUSTIC EMISSION
EVENTS VERSUS TEST FLIGHTS FOR TEST CRACK 5J.

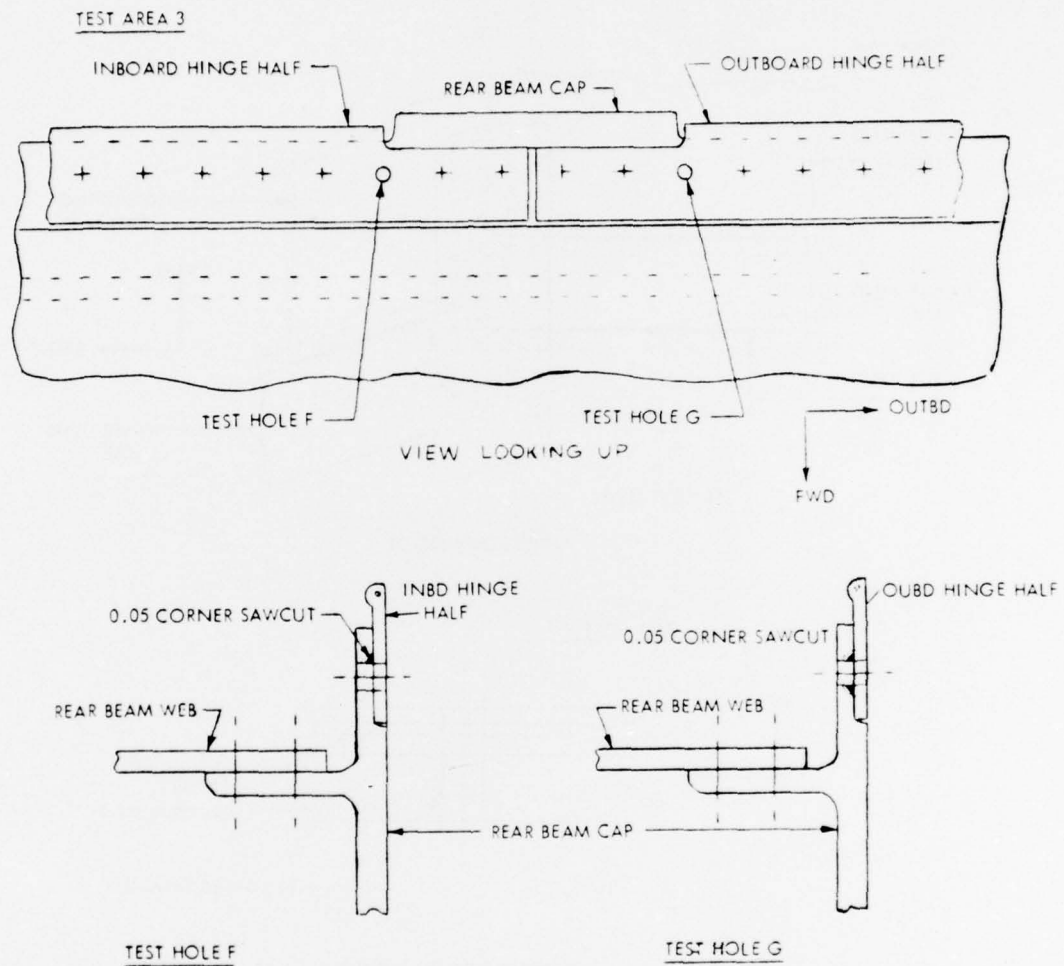
FIGURE F3. CONDITIONS AT TEST HOLE F AND G IN TEST AREA 3

Test Area 3, Test Holes F and G. Both cracks F and G grew from corner sawcuts during the program test flights. A diagram of Test Area 3, the sawcuts and final cracks is given in Figure F3. Crack F extended 0.035 inches along the 45° bi-sector toward the aft edge of the rear beam cap hinge lip. Crack G extended 0.035 inches aft and 0.055 inches forward (along 45° bisectors) from the hole. Neither crack received further analysis for correlation to test flights or growth increment segregation.

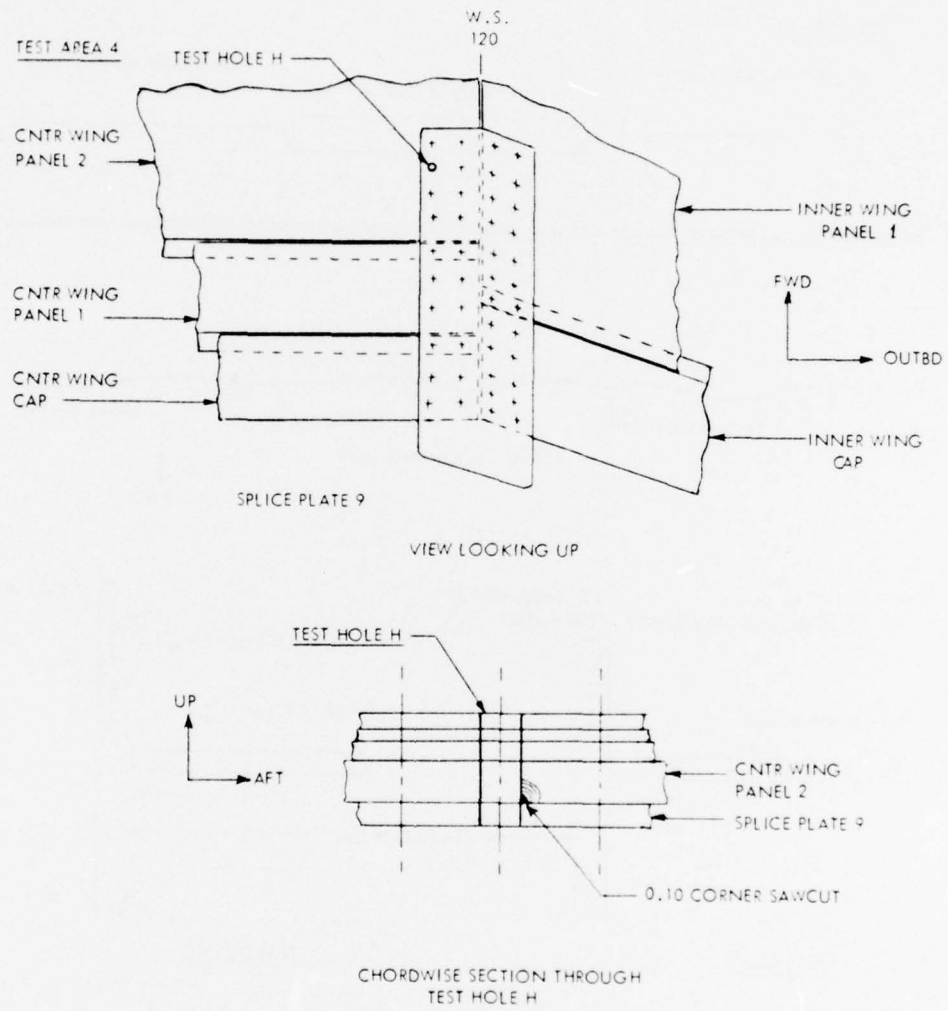
Test Area 4, Test Hole H. Figure F4 is a diagram of Test Area 4, including the sawcut and final crack. Crack H extended 0.175 inches along the 45° bisector from a corner sawcut in the test hole. This crack was analyzed for growth correlation to test flight and for segregation of growth due to the residual strength test loads. An increment of 0.140 inches of the above growth occurred during the flight-by-flight tests. Growth occurred steadily throughout the latter program.

FIGURE F4. CONDITIONS AT TEST HOLE H IN TEST AREA 4.

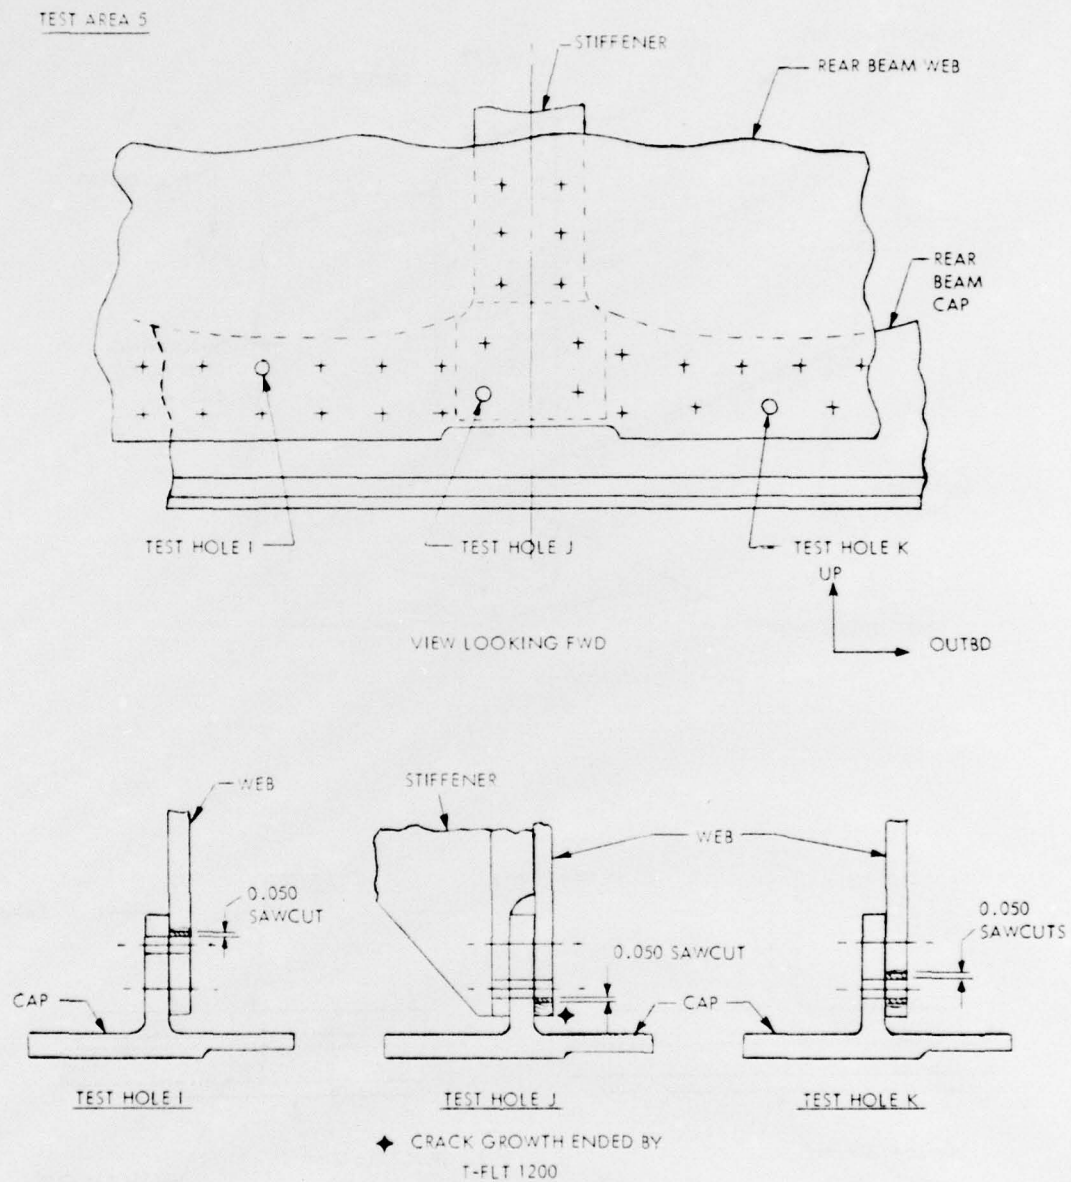
Test Area 5, Test Hole I, J and K. Crack growth occurred in all three test holes. A diagram of Test Area 5, the sawcuts and final cracks is shown in Figure F5. Crack I grew from a through-sawcut on the upper side of a fastener hole in the web. Growth was 0.050 inches as measured along the surface of the web. Crack J extended 0.247 inches from a through-sawcut on the lower side of a fastener hole to the lower edge of the web. This crack reached the edge of the web just prior to test flight 1200 and no further growth occurred at this hole. Crack K grew 0.033 inches on the upper side of a fastener hole in the web and 0.050 inches on the lower side of the hole – each extending from a through-sawcut in the web. Only Crack J was analyzed for growth correlation to test flights.

FIGURE F5. CONDITIONS AT TEST HOLE I, J, AND K IN TEST AREA 5

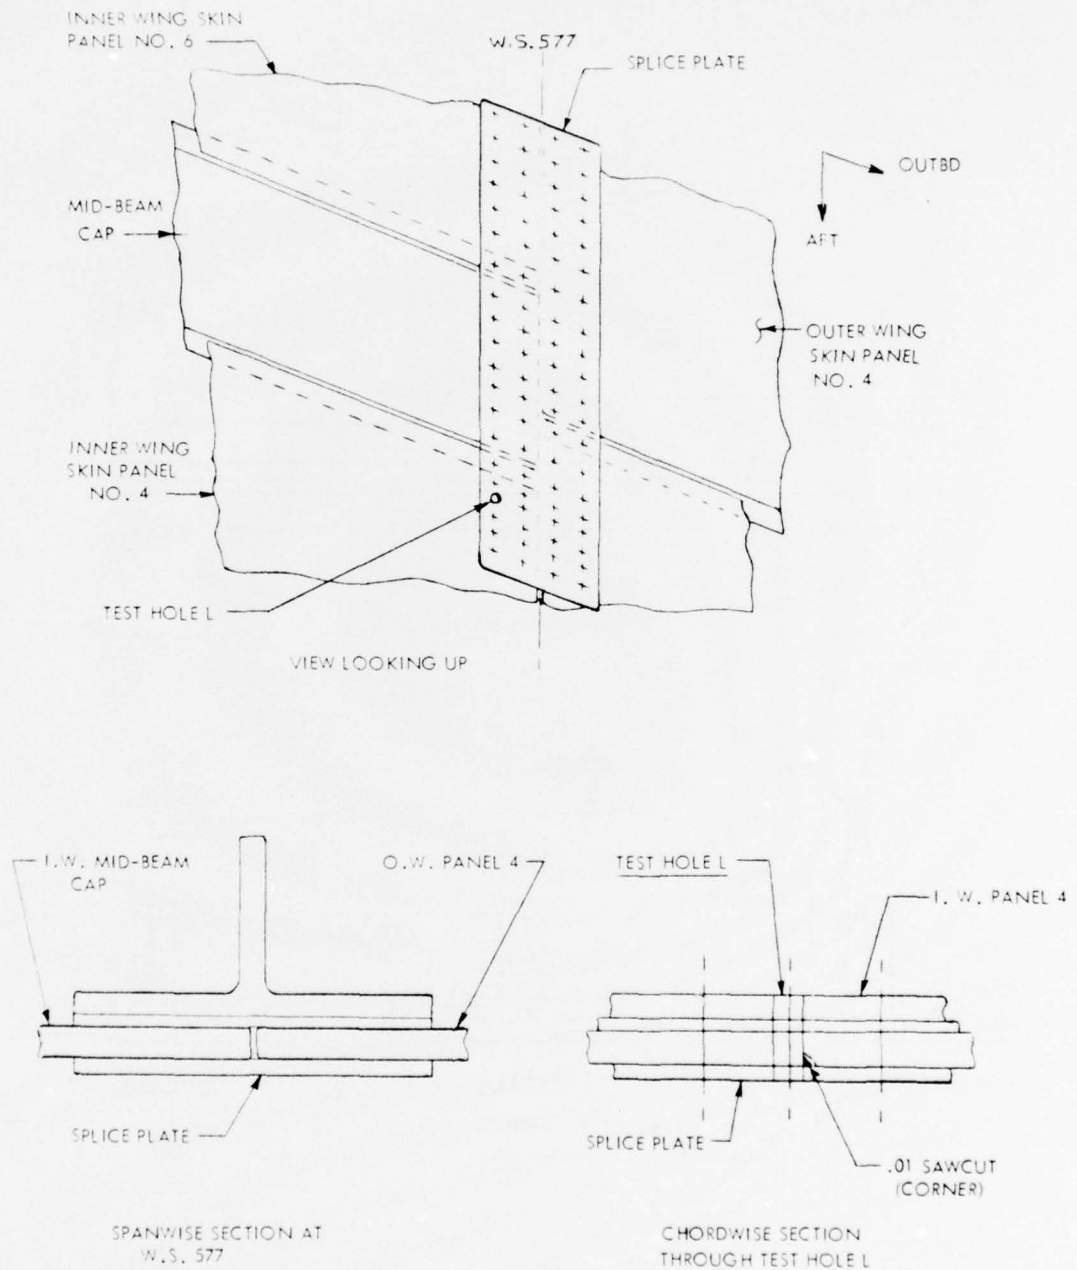
Test Area 6, Test Hole L. A diagram of Test Area 6, the sawcut and final crack is given in Figure F6. A crack 0.020 inches as measured along the 45° bisector extended from a corner sawcut in Test Hole L. This crack was not analyzed further.

FIGURE F6. CONDITIONS AT TEST HOLE L IN TEST AREA 6

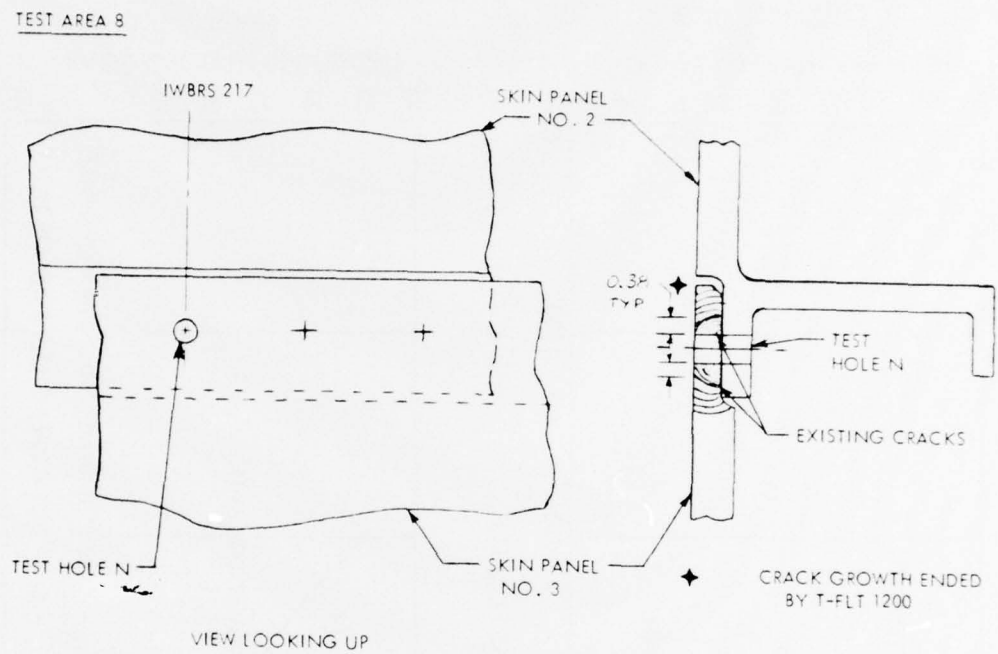
FIGURE F7. CONDITIONS AT TEST HOLE N IN TEST AREA 8

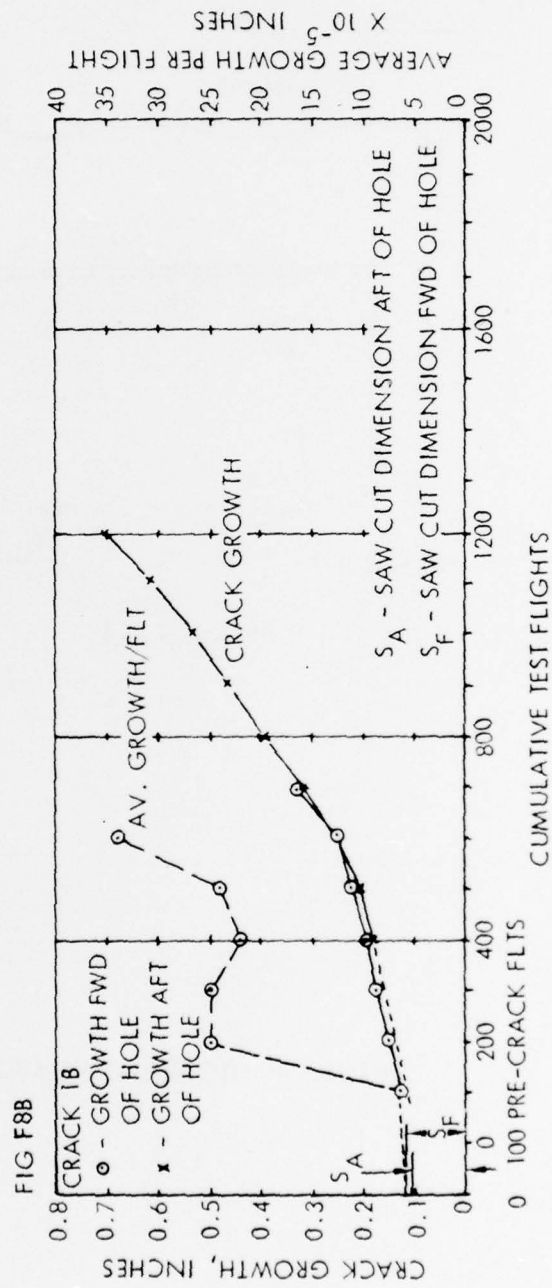
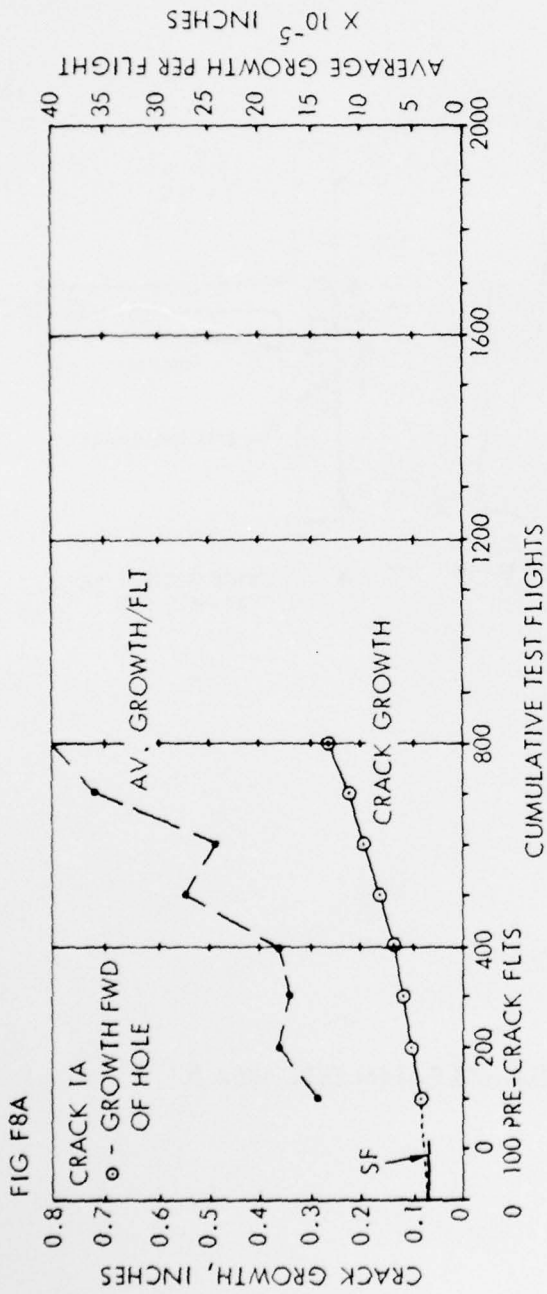
FIGURE F8. CRACK GROWTH VERSUS CUMULATIVE TEST FLIGHTS (1 OF 3)

Crack growth histories of analyzed cracks 1A, 1B, 2 '0', 4H and 5J are depicted by data plots shown in Figure F8 (Figures F8A, F8B, F8C, F8D, and F8E, respectively). Photographs of the fracture faces of these cracks are shown in Appendix F which exhibits photos of all the test cracks. In these plots, crack length and average growth per flight are plotted as a function of test flight. The left end of the crack length curves are shown emanating from the boundary dimension of the initial sawcut or initial fatigue crack. The x-axis (flight axis) includes the first 100 "precrack" flights that were applied before the 2000 test flights. Crack growth was experienced at all test holes, except hole 1C, during the 2100 crack initiation and propagation flights. Test cracks not analyzed for growth versus flight history are 2E, 2P, 2Q, 3F, 3G, 5I, 5K and 6L.

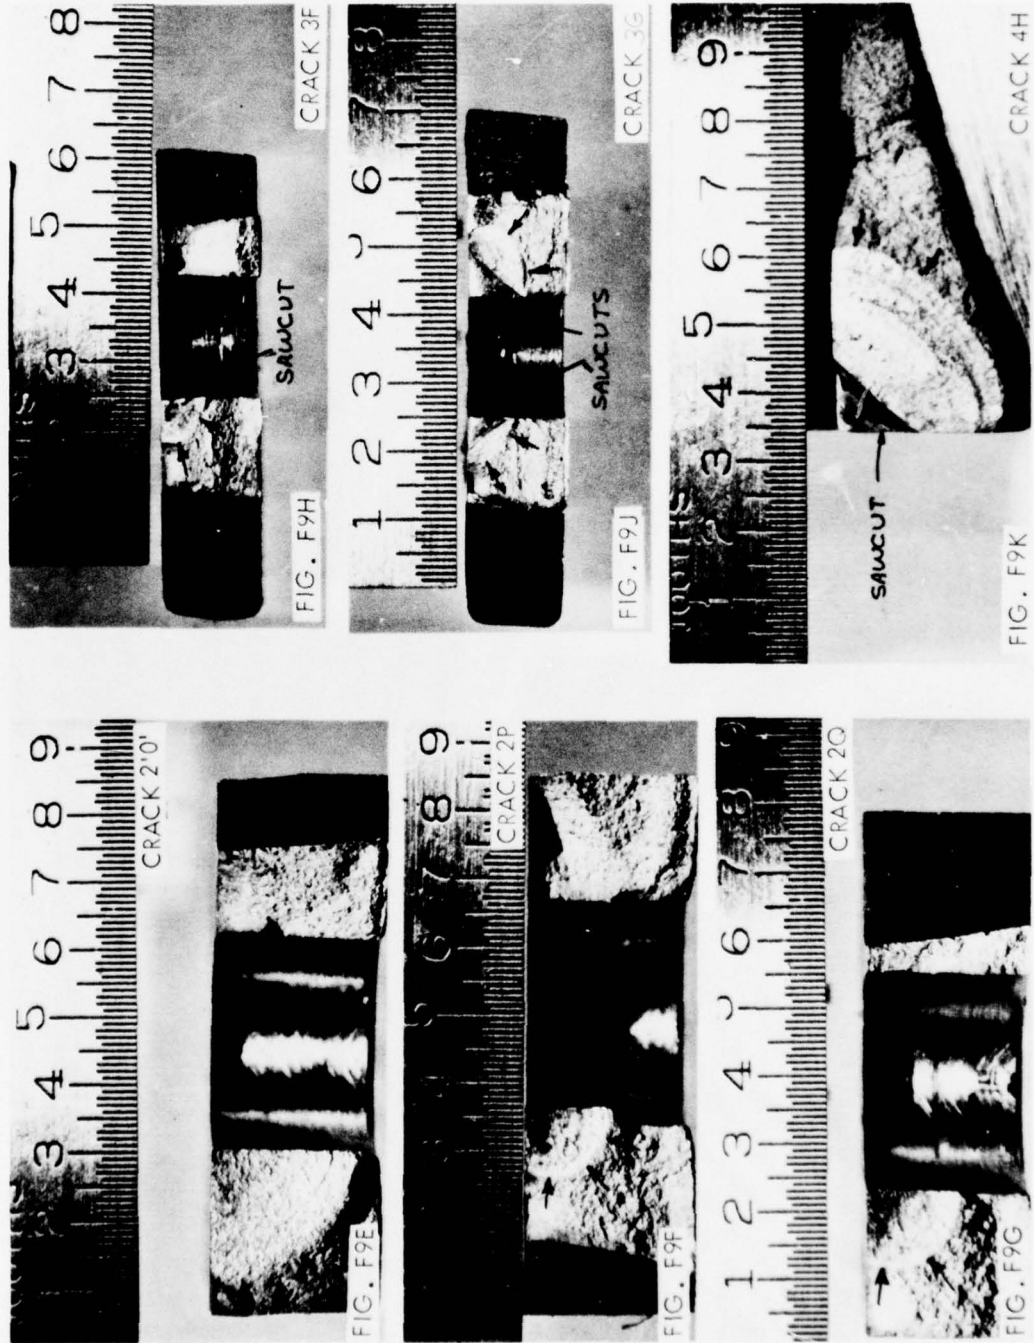
FIGURE F9. PHOTOMACROGRAPHS OF TEST CRACK SURFACES (1 OF 3)

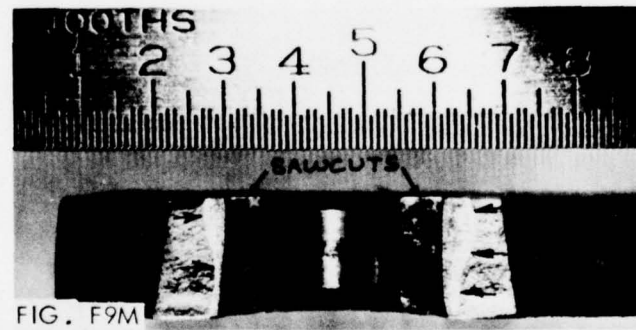
CRACK 6L

FIGURE F9   PHOTOMACROGRAPHS OF TEST CRACK SURFACES (3 OF 3)

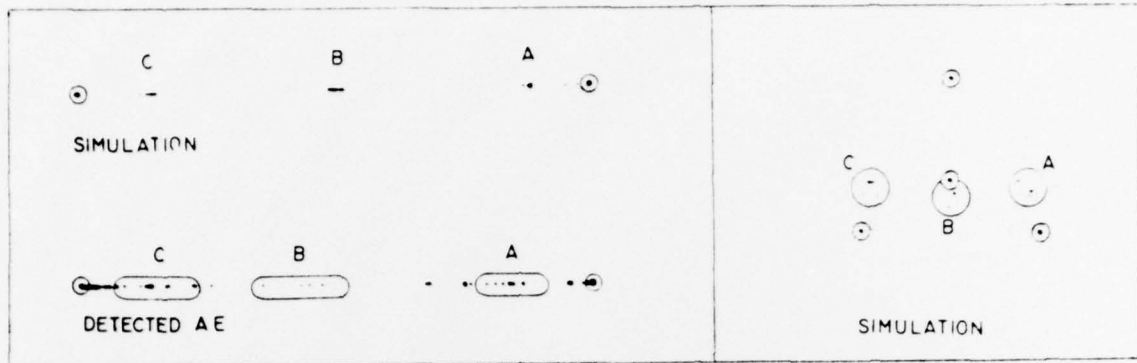
FIGURE H1. AE REPRESENTATIONS FROM TEST AREA 1

The array in Test Area 1 was linear array through Flt 800. The presentations on the left of the block for linear array 0/1 contain a display (top) of simulated signals injected at test holes A, B, and C, and a display of AE signals plus noise detected during Flt 530. The display on the right is a triangular representation of simulated signals injected at the test holes. Since cracks at A and B had little or no growth after this array was deployed, a suitable triangular display of detected AE was not available.

Test Area 1, Test Holes A & B. Area 1 was monitored with a linear array through flight 800, which was then replaced with a triangular array. The triangular array was modified again after flight 1200 in an attempt to improve the AE detectability. The latter modification, described in Section 3.1.4C, included a wing joint within the array. Since crack growth had virtually ceased in hole A before flight 800 and growth was continuing aft from hole B only, the triangular arrays did not witness much AE activity. The AE from hole B were intermingled with a relatively high noise incidence and were also being indicated in a virtual location varying from the true position because of structural effects. The previous linear array appeared to indicate AE from holes A and B, but it was not possible to verify them as true crack growth AE in the presence of the high noise. The triangular arrays had the potential of resolving the AE identity difficulties if significant crack growth had continued.

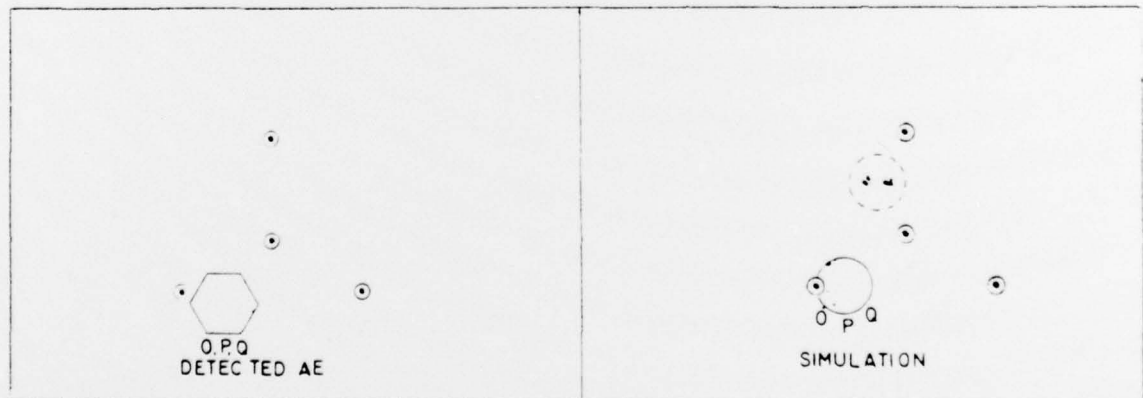
FIGURE H2. AE REPRESENTATIONS FROM TEST AREA 2

The triangular array presentation shows real AE crack growth from test area 2 on the diagram at the left and simulations in the diagram on the right. Other indications on left diagram are primarily nonrepeating random noise signals. The simulation on the right shows a displacement for indications made at the test hole on an adjacent faying member.

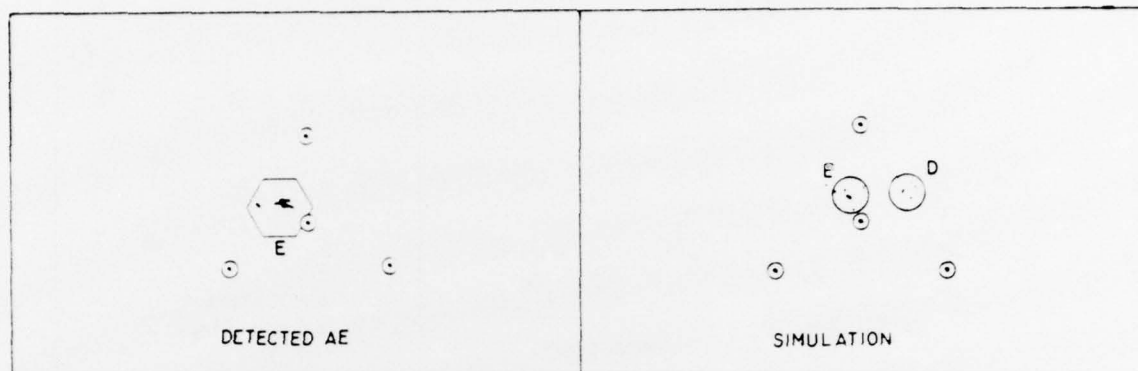
FIGURE H3.   AE REPRESENTATIONS FROM TEST AREA 2

Triangular presentation on left is AE detected during flight 1625
from test hole E in test area 2.   Right presentation shows simula-
tions made on the mid beam cap riser at test holes E and D.

Test Area 2, Test Holes D and E. Early attempts to monitor growth at these test holes were not successful using a linear array. After a triangular array was mounted on the beam cap following flight 1200, this array consistently picked up AE from hole E through flight 2000. These are plotted in Figure 11 and tabulated in Table I. The occasional emissions from hole D lost intensity in propagating from the web to the array and were, therefore, less reliably indicated.

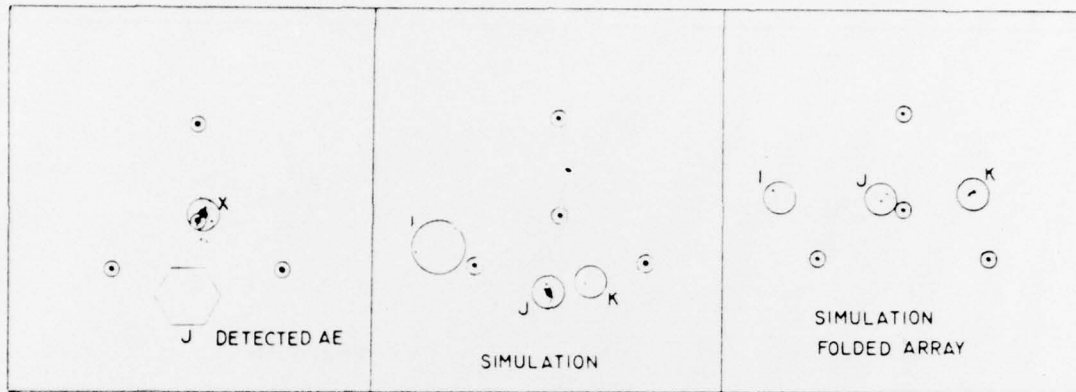
FIGURE H5. AE REPRESENTATIONS FROM TEST ARE 5

Triangular presentation on left includes AE from test hole J
in test area 5, repetitious AE from unknown source at X and
nonrepeating random noise. Two presentations on right show
simulations made at test holes I, J and K for the arrays in-

Test Area 5, Test Holes I, J and K. AE from hole J was received by the initial triangular array until the crack reached the lower edge of the web just prior to flight 1600. The crack was removed at the end of 1650 flights for fractographic examination. A plot of the AE from J is shown in Figure 11 and the data are tabulated in Table i. The emission rate was very sporadic throughout the flights. AE from holes I and K were not identifiable as coming from a distinct source. This was attributed to the complex stiffener and cap splice joints and to the positioning of the array so that I and K were in the vicinity of the apex transducers 1 and 2, respectively (see Section 3.1.4B). The final experimental array installed following Flight 1600 did not reliably indicate emissions from holes I and K. Several early extraneous emitters were located at fastener holes in a nearby stiffener attachment area and were found to be related to loose fasteners.
